On-Site findings from visit to	WBHO/TIBER
Date:	2015/03/04
Machine Type:	Bobcat
Tyres Supplied:	Skid Steer Solid cushion (10")

Executive Summary

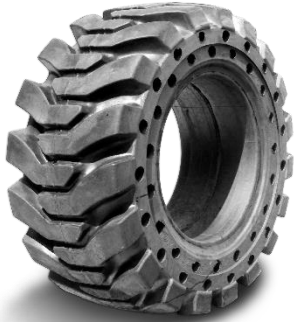
The Skid Steer tyres were recommended for this application.

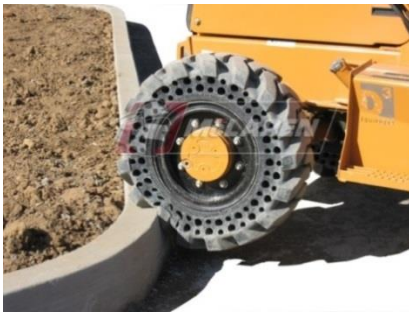
Cushion effect to ensure machine is not negative affected.

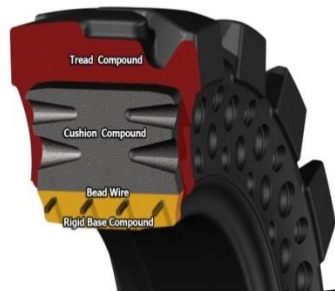
Second phase in the life of the tyre provides an extra 60% longer life.

The 10" Solid skid steer tyre had a tread depth of 40mm when new. There was an average of 2.2mm wear on the tyres over a 148 hour period. Therefore, according to the wear patterns being demonstrated, a total of hours exceeding 2400hrs are projected on this set of tyres. There are two phases in the life of the tyre. The first phase wears only on the lugs and the second phase wears on the remaining lugs and centre cushion built into the tyre. The second phase provides a 60% longer life because there is an increase in the contact area is increased.

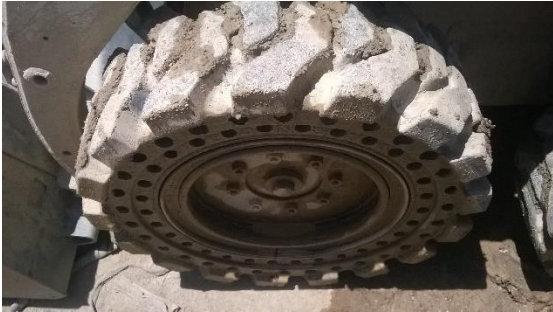
<p>1.</p>

- Front left tyre 38.40mm tread left
- Rear left tyre 38.50mm tread left
- Rear right tyre 36.50mm tread left
- Right front tyre 37.90mm tread left

<p>Pic 1: Showing front left tyre Pic 2: Showing rear left tyre Pic 3: Showing rear right tyre Pic 4: Showing right front tyre</p>
