On-Site findings from visit to Active Hire
Date: 2015/01/22
Machine Type: CAT 422F
Tyres Supplied: 12" Solid Cushion
Tyres

Executive Summary

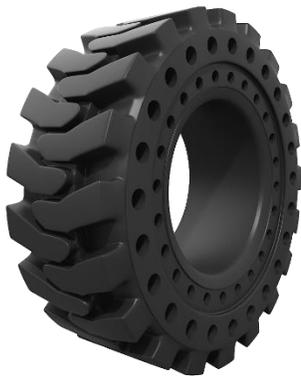
12” Front solid cushion TLB tyres were recommended for this application.

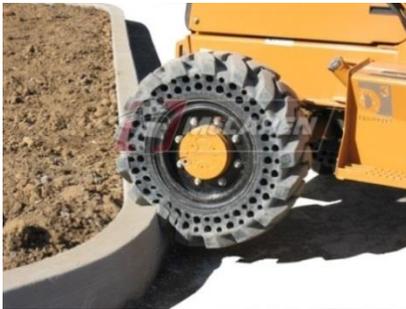
Cushion effect to ensure machine is not negative affected.

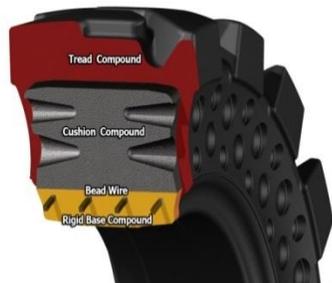
Second phase in the life of the tyre provides an extra 60% longer life.

The 12" Solid cushion tyres had a tread depth of 50mm when new. There was an average of 12.56mm wear on the tyres over a 1583 hour period. Therefore, according to the wear patterns being demonstrated, a total of hours exceeding 5000hrs are projected on this set of tyres. There are two phases in the life of the tyre. The first phase wears only on the lugs and the second phase wears on the remaining lugs and centre cushion built into the tyre. The second phase provides a 60% longer life because there is an increase in the contact area is increased.

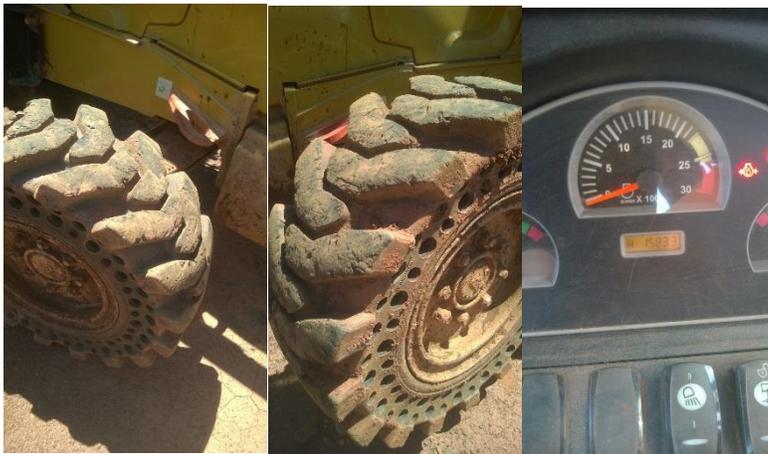
- Front right tyre 37.27mm tread left
- Front left tyre 37.61mm tread left

The average tread left on the tyres on 2015/01/22 was 37.44mm

Pic 1: Showing front right tyre 37.27mm tread left

Pic 2: Showing front left tyre 37.61mm tread left

Pic 3: Hour meter on machine – 2015/01/22
